PHASE I ENVIRONMENTAL ASSESSMENT REPORT (ASTM E 1527-21)

Performed on:
388-A & 402
Estate Anna's Retreat
New QTR
St. Thomas, VI 00802

Issue Date: April 7, 2024

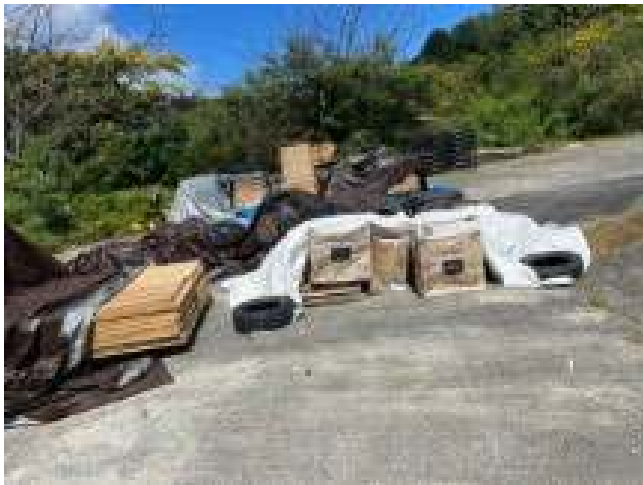
Construction material, including treated plywood, staged outside.

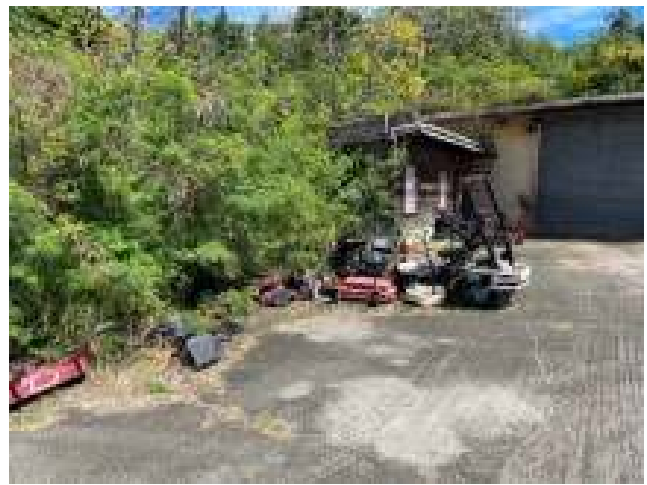
Oil-filled small equipment staged outside at Subject Property.

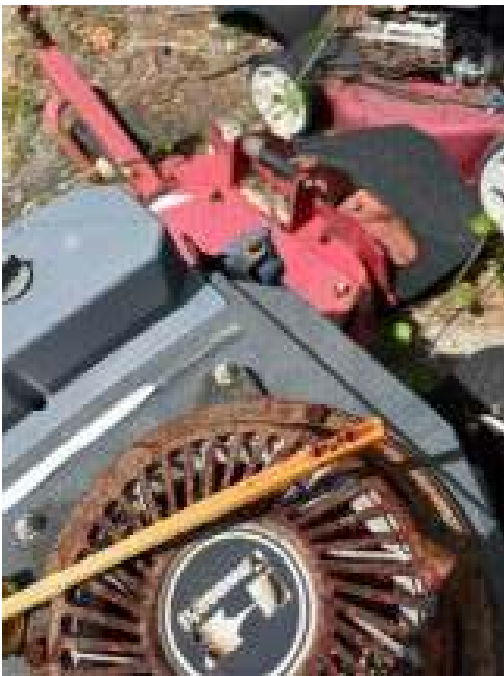
Evidence of oil in small equipment, staged outside.

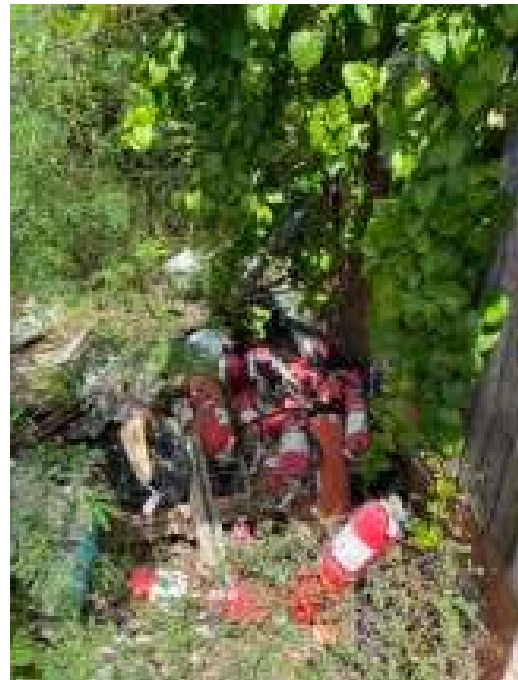
ABC fire extinguishers stockpiled outside at Subject Property.

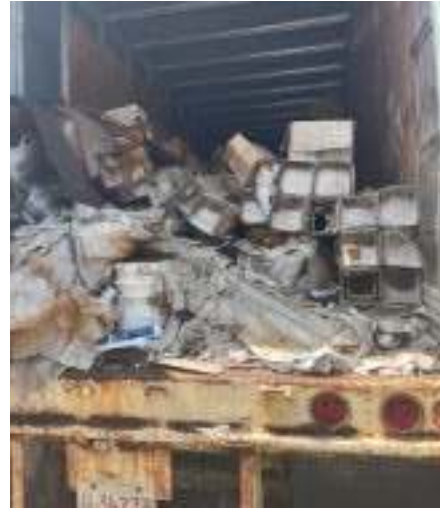
Damaged materials stored in trailers.

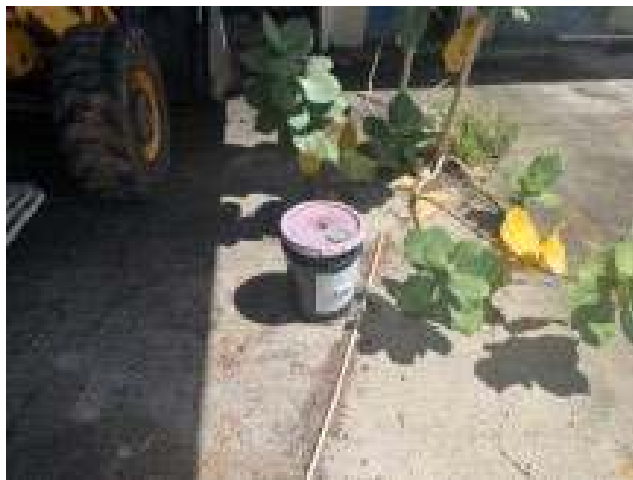
5-gallon bucket containing petroleum product located outside on slab.

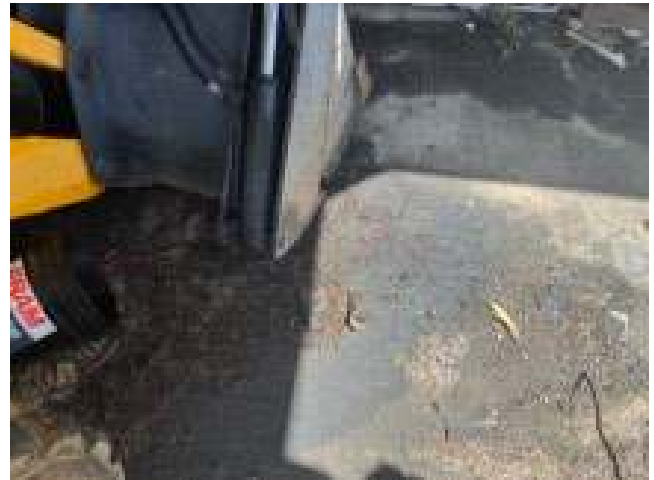
Petroleum staining around heavy equipment stored on slab.

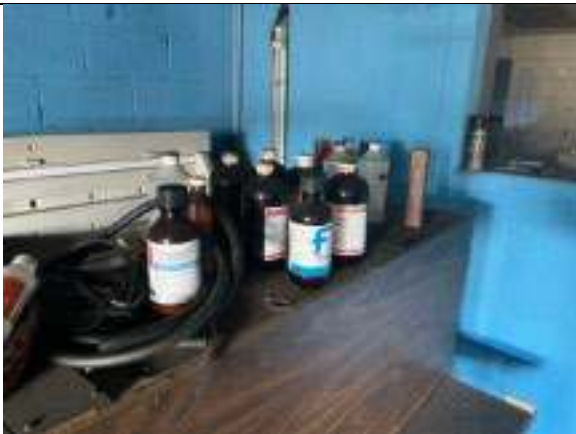
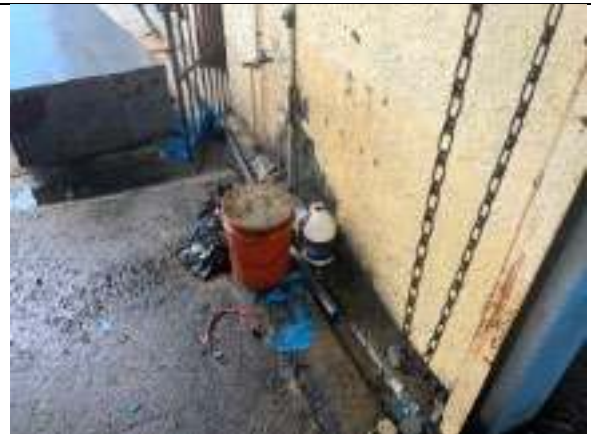
<p>Chemical products, including hazardous chemicals (e.g. formaldehyde), stored onsite.</p>	<p>Petroleum mixed with water in open 5-gallon, with spilled material on concrete slab.</p>

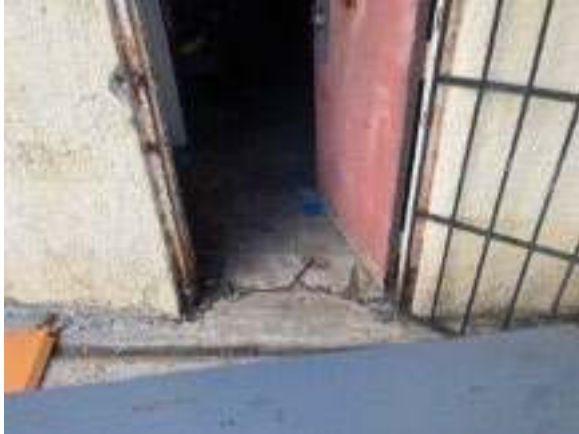
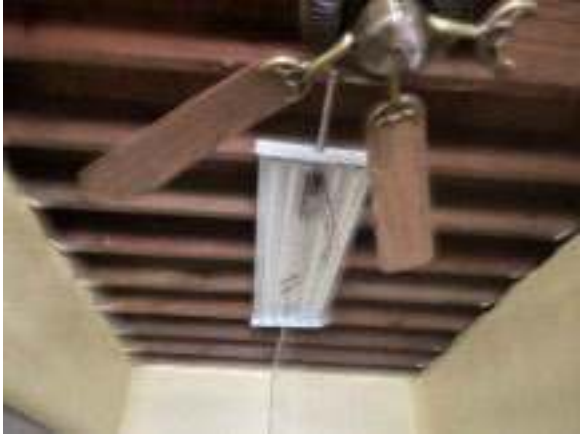
<p>Suspected ACM material (floor tile).</p>	<p>Suspected PCB ballast for florescent light fixture.</p>

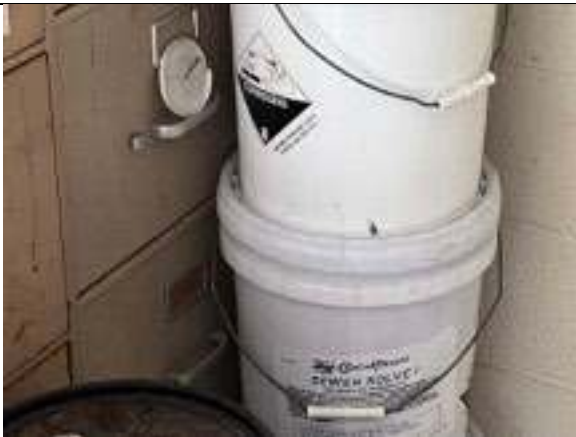
Hazardous chemicals stored in 5-gallon buckets inside building.

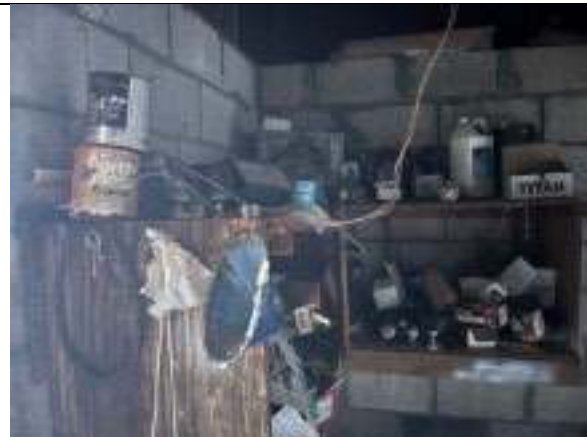
Various chemicals, some hazardous, stored in maintenance shed.

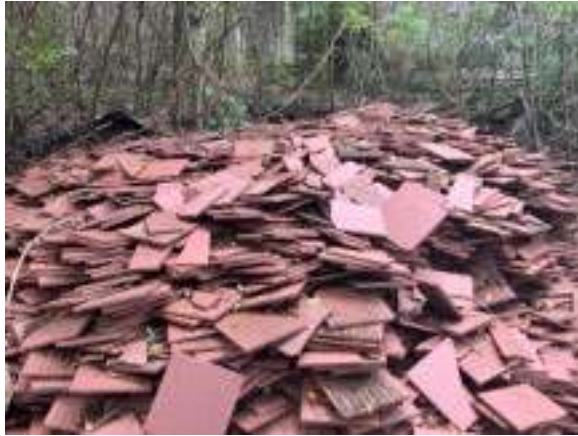
Piles of construction debris (e.g. terracotta tile)

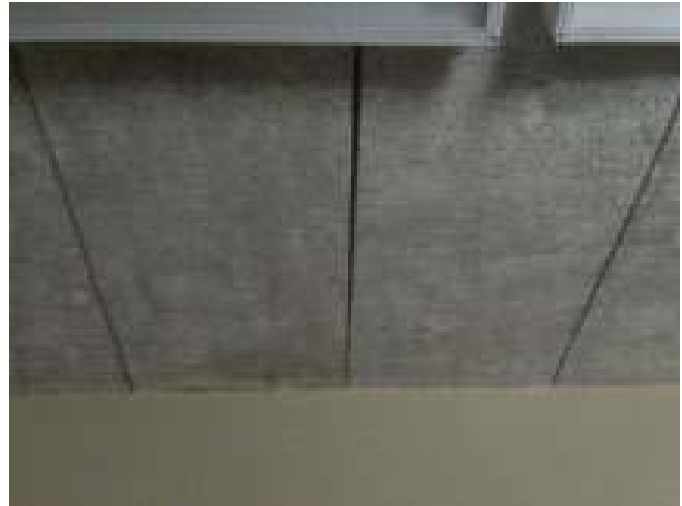
Suspected ACM material (ceiling tile).

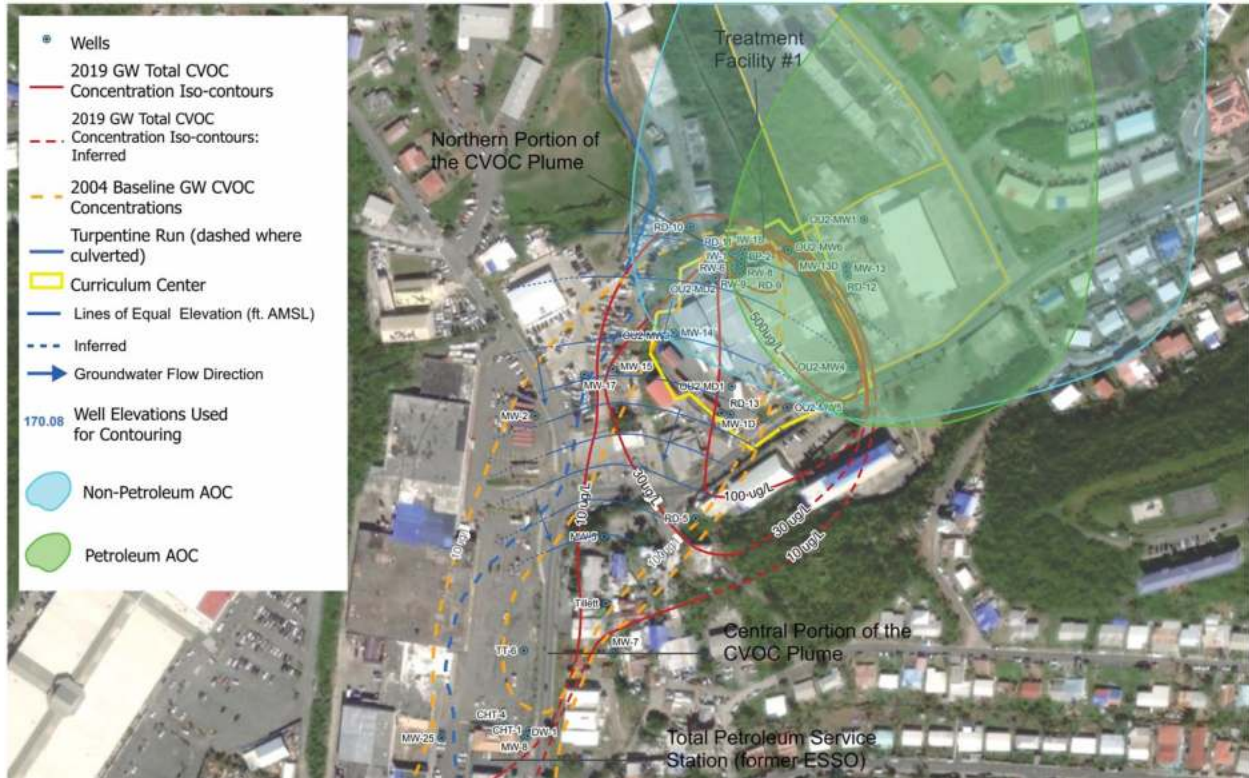
Figure 13. Tier 1 VES AOC Estimation, St. Thomas, USVI (Basemap: Record of Decision (ROD) Document, United States Environmental Protection Agency, September 2021)

Based on this AOC and overlap with the most recent plume shape drawn from known groundwater contamination concentrations, it was determined that a VEC exists for the Subject Property.
