PHASE I ENVIRONMENTAL ASSESSMENT REPORT (ASTM E 1527-21)

Performed on:
388-A & 402
Estate Anna's Retreat
New QTR
St. Thomas, VI 00802

Issue Date: April 7, 2024

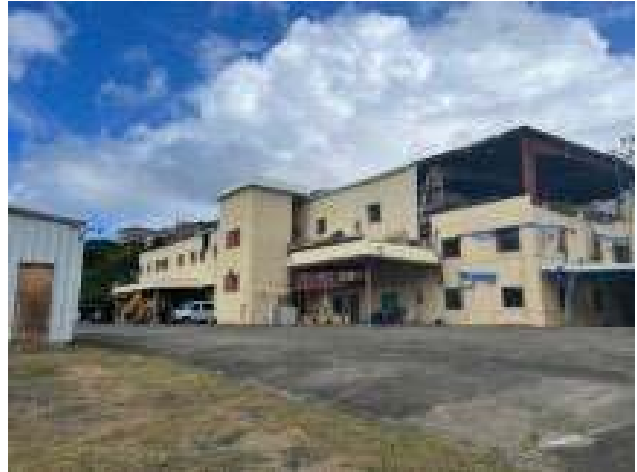
Subject Property, central office, facing Northeast.

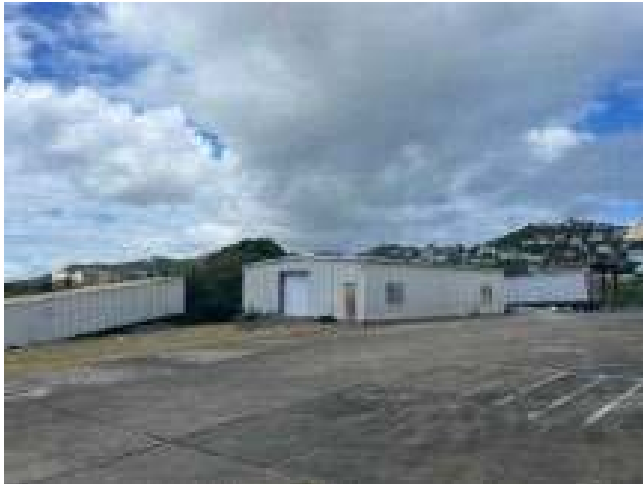
Subject Property, maintenance building, facing Northwest.

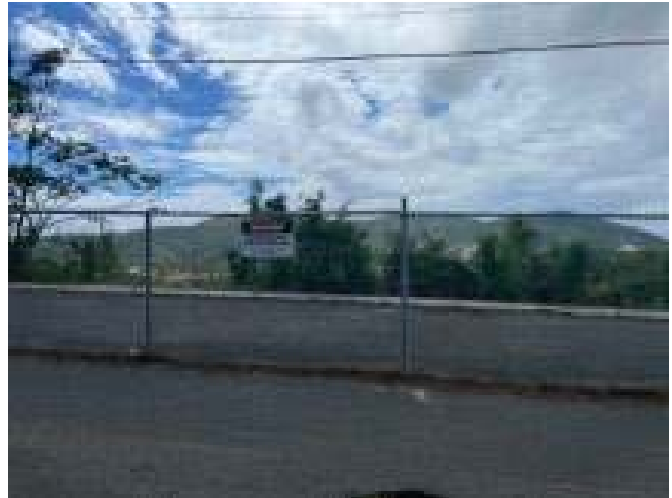
Subject Property, former Senior Center residences, facing west.

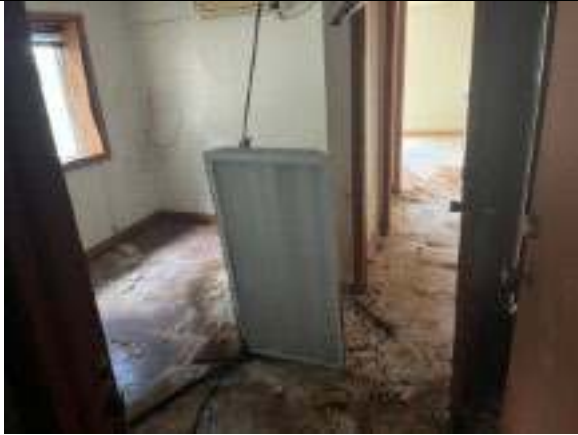
Suspected ACM material (floor tile). Suspected PCB ballast in light fixture.

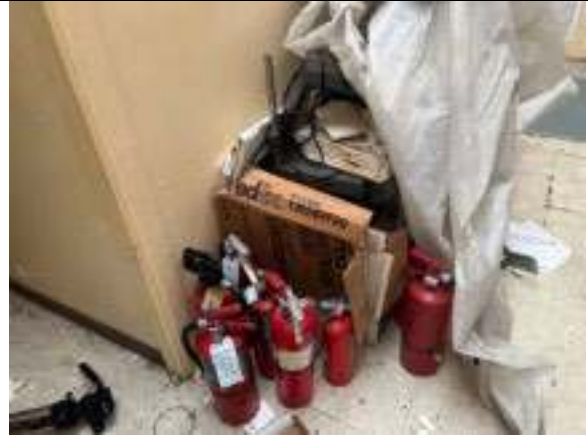
ABC Fire Extinguishers staged inside.

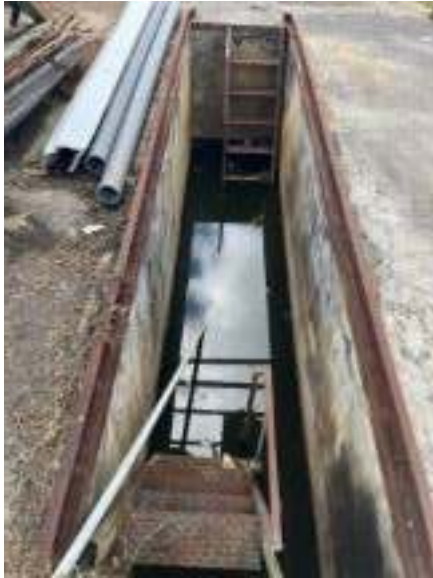
Vehicle Maintenance Pit with collected stormwater. No sheen or odor present to suspect contamination of water.

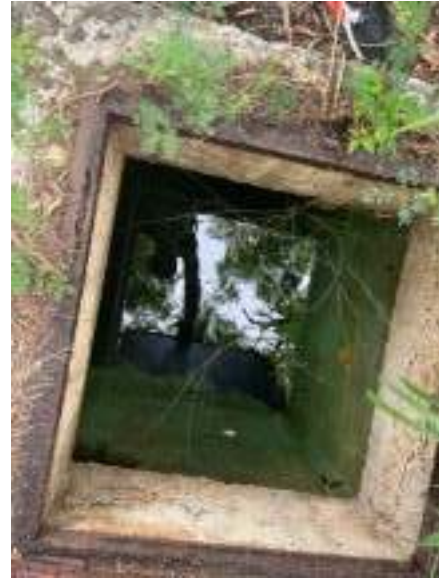
Sump/pit onsite with water. No sheen or odor present to suspect contamination of water.

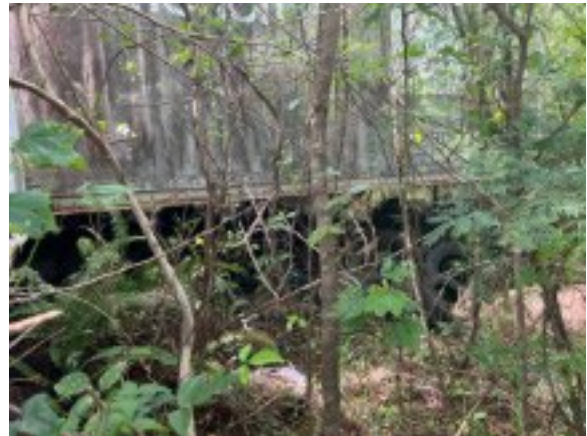
Used tires stored under trailers.

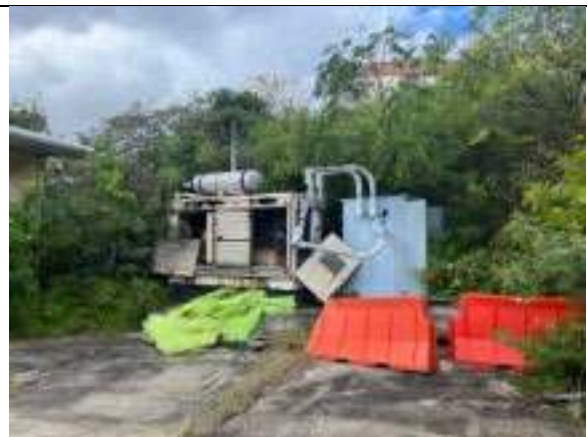
Existing emergency generator for site. Electrical switch gear suspected to contain transformer oil.

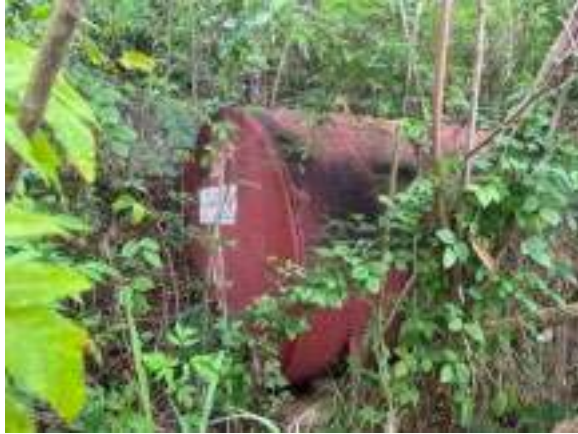
Existing 5,000-gallon fuel tank. No secondary containment, unknown if double-walled. Suspected to contain diesel fuel of unknown quantity.

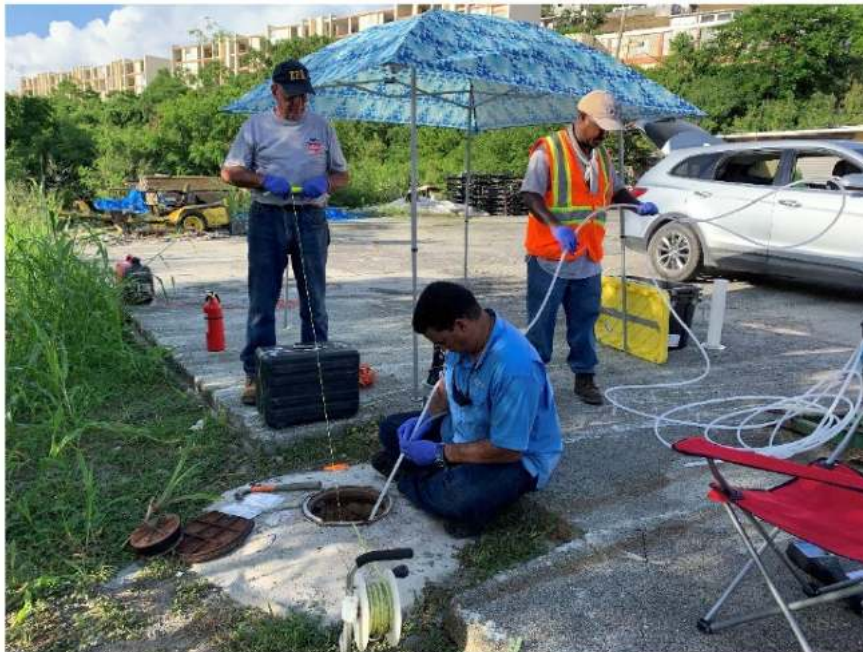
Figure 11. MW-13D on Subject Property, St. Thomas, USVI (Final Monitoring and Residential Well Sampling Report Tutu Wellfield Site, United States Environmental Protection Agency, January 2020)

Table 12 below shows test results from historical testing as well as samples taken before and after hurricane events. MW-13D was found to have PCE levels of 13 ug/L.
