PHASE I ENVIRONMENTAL ASSESSMENT REPORT (ASTM E 1527-21)

Performed on:
388-A & 402
Estate Anna's Retreat
New QTR
St. Thomas, VI 00802

Issue Date: April 7, 2024

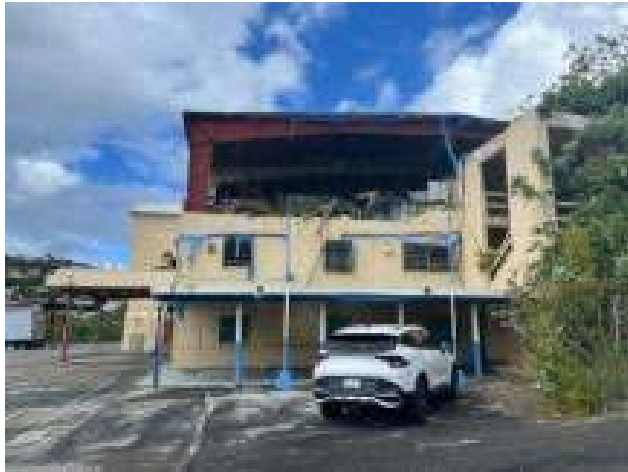
Subject Property, central office, facing North.

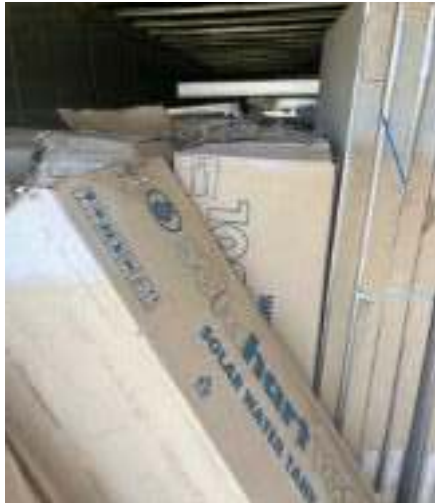
Solar Water Heater Tanks and Panels stored in trailer.

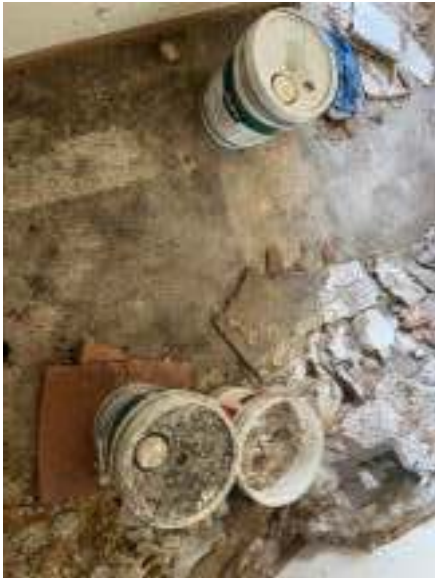
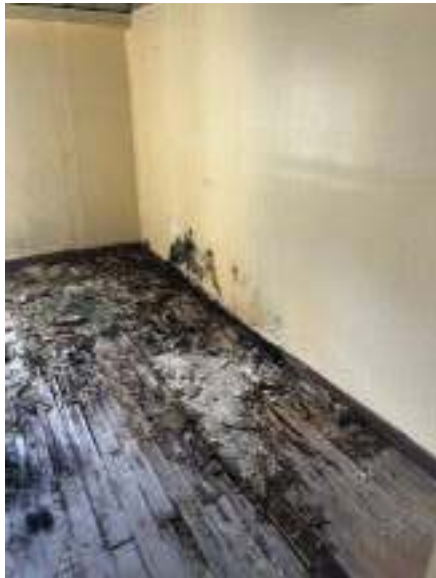
<p>Suspected ACM material (floor tile).</p>	<p>Suspected mold on floor and walls.</p>

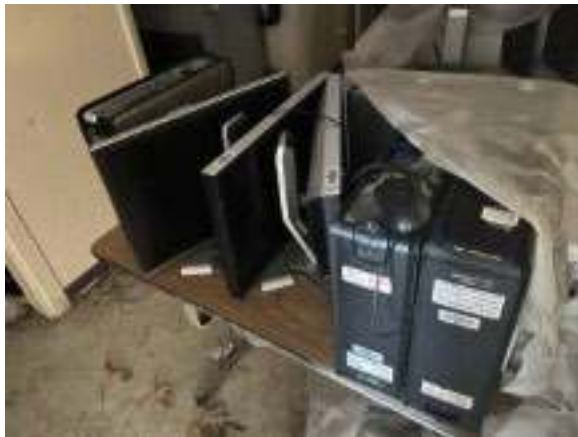
Electronic waste.

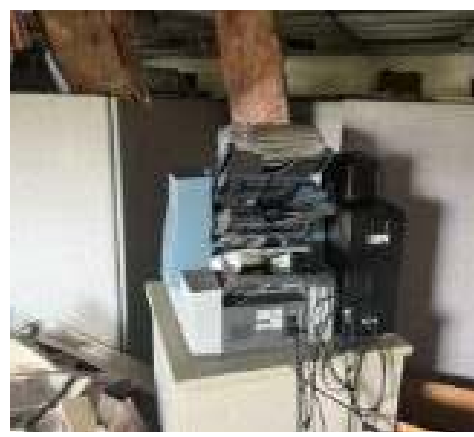
Electronic waste.

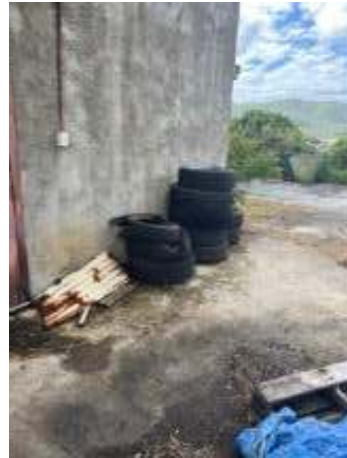
Used tires stored outside.

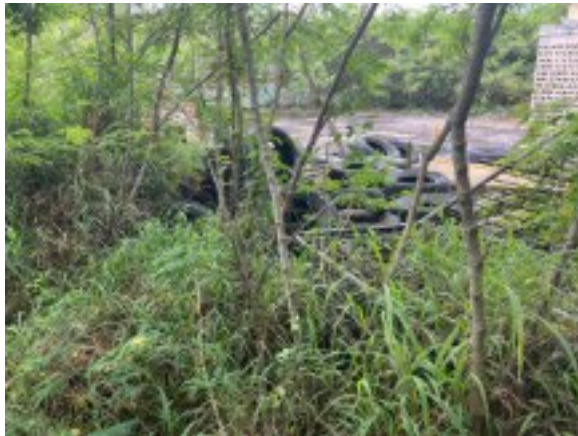
Used tires piled outside.

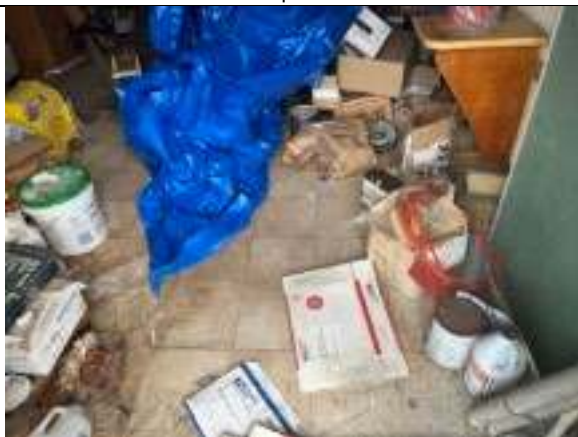
Suspected ACM material (floor tile).

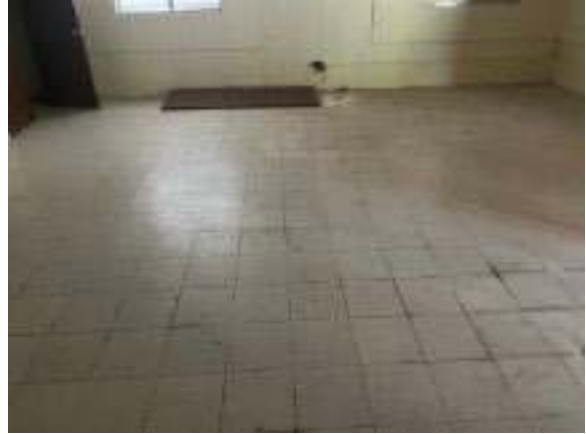
Suspected ACM material (floor tile).

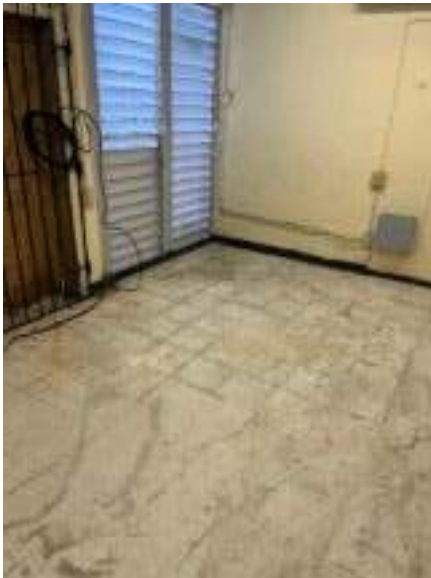
Suspected ACM material (floor tile).
